**VOLUNTARY CLEANUP COMPLETION REPORT
FOR THE
GRAND VIEW SMELTER SITE
RICO, COLORADO**

September 17, 1999

TECHNICAL MEMORANDUM

RECLAMATION MONITORING RESULTS FOR THE GRAND VIEW SITE

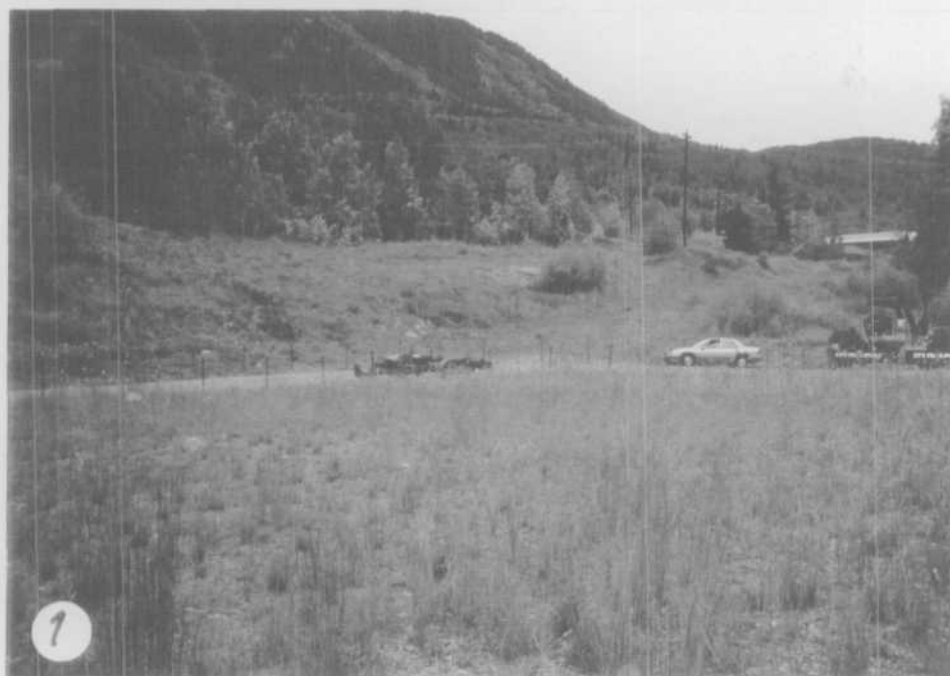
Photo #	Description
1	Near northern project area border looking south across site.
2	Near western project area border looking east across southern one-half of site.
